MOULTON CREEK DAM NO. 1 MT -1467

BASIN CREEK DAMS NO'S 1 AND 2 MT-374 MT-868 BUTTE, MONTANA

SEATTLE DISTRICT, U. S. ARMY CORPS OF ENGINEERS

DAM SAFETY INSPECTION

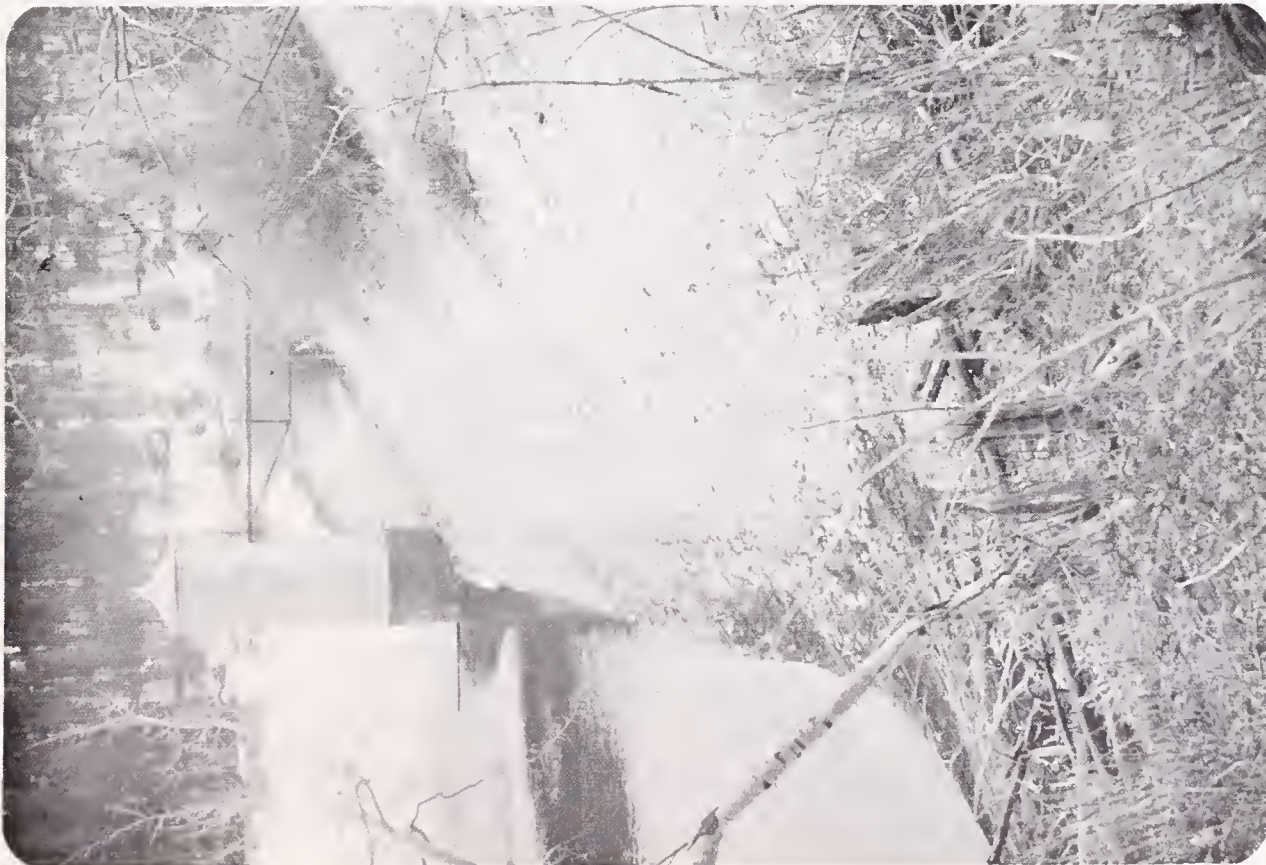
Photo 2. Wet-well tower and upstream face

The pipe intakes have never been inspected to the knowledge of Butte Water Department personnel. The wet-well tower was not inspected because access to the base was not available. However, the tower is encased in steel plate below an elevation of about 6,757 feet, while the upper portion is concrete. A large crack one-half inch wide extends from the steel liner to the tower floor with smaller branch cracks. No reinforcing steel was exposed. Exterior horizontal reinforcement is provided by two circular tie bars with turnbuckles located slightly above the upper deck level.

- a. No access down the wet-well tower exists.
- b. Cracks exist in tower walls.
- c. Wet-well tower and intake to outlet pipes have not recently been inspected.

b. Rehabilitate wet-well tower by repairing cracks in wall and provide for ease of inspection by installing lighting system (portable) and safe access to and down the tower.

3.1.2.3 Conduct an inspection of the wet-well tower and pipes passing through embankment. Repair as needed.

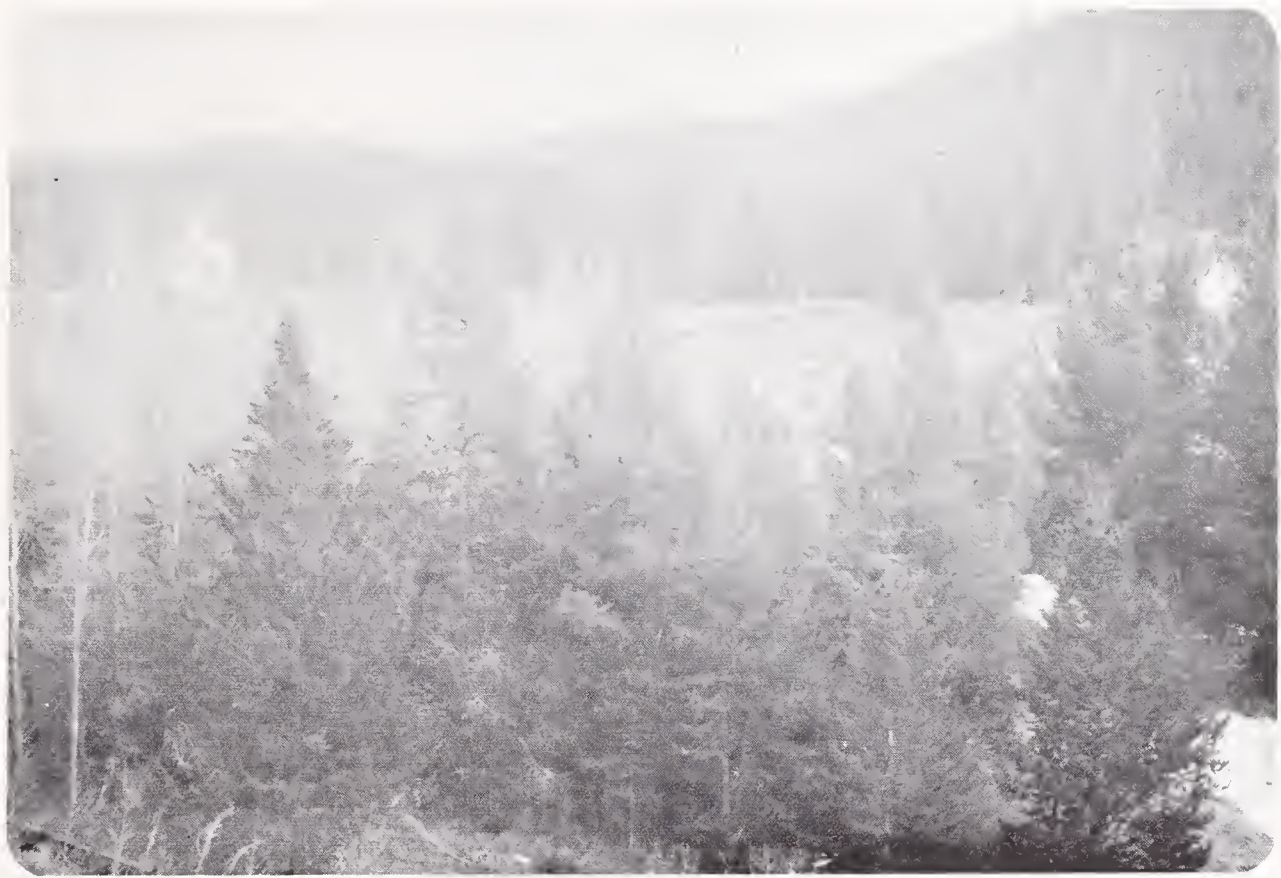
Photo 3. Downstream Face

the left abutment drainage tunnel. The slump scarp, several inches deep by about 50 feet wide, is located about 8 feet below the dam crest. The downstream shoulder of the dam crest above the slump appeared to have settled about 1 to 1.5 feet. Water was ponded in ruts in the dam's crest caused by vehicles. According to the design drawing and verbal reports, seepage control through and beneath the embankment was achieved with a central concrete core wall which rises to within 8 feet of the dam's crest. Top of core wall is at elevation 6,748 feet, only 1 foot above normal full pool elevation. If the reservoir level rises above the top of the core wall and the materials above the core wall are not sufficiently impervious, water may pass over the core. Whether or not this water would cause instability problems in the downstream slope depends on whether the materials are sufficiently pervious to pass seepage without building dangerous piezometric pressures.

- c. An old slump exists on the downstream slope above the left abutment drainage tunnel.
- d. Clear seepage water was observed flowing from the left abutment drainage tunnel. No provision to measure seepage water exists. Previous attempts to cut off seepage were apparently made as evidenced by the old grout pipes which remain in the embankment crest near the left abutment. The effectiveness of this grouting program is unknown.

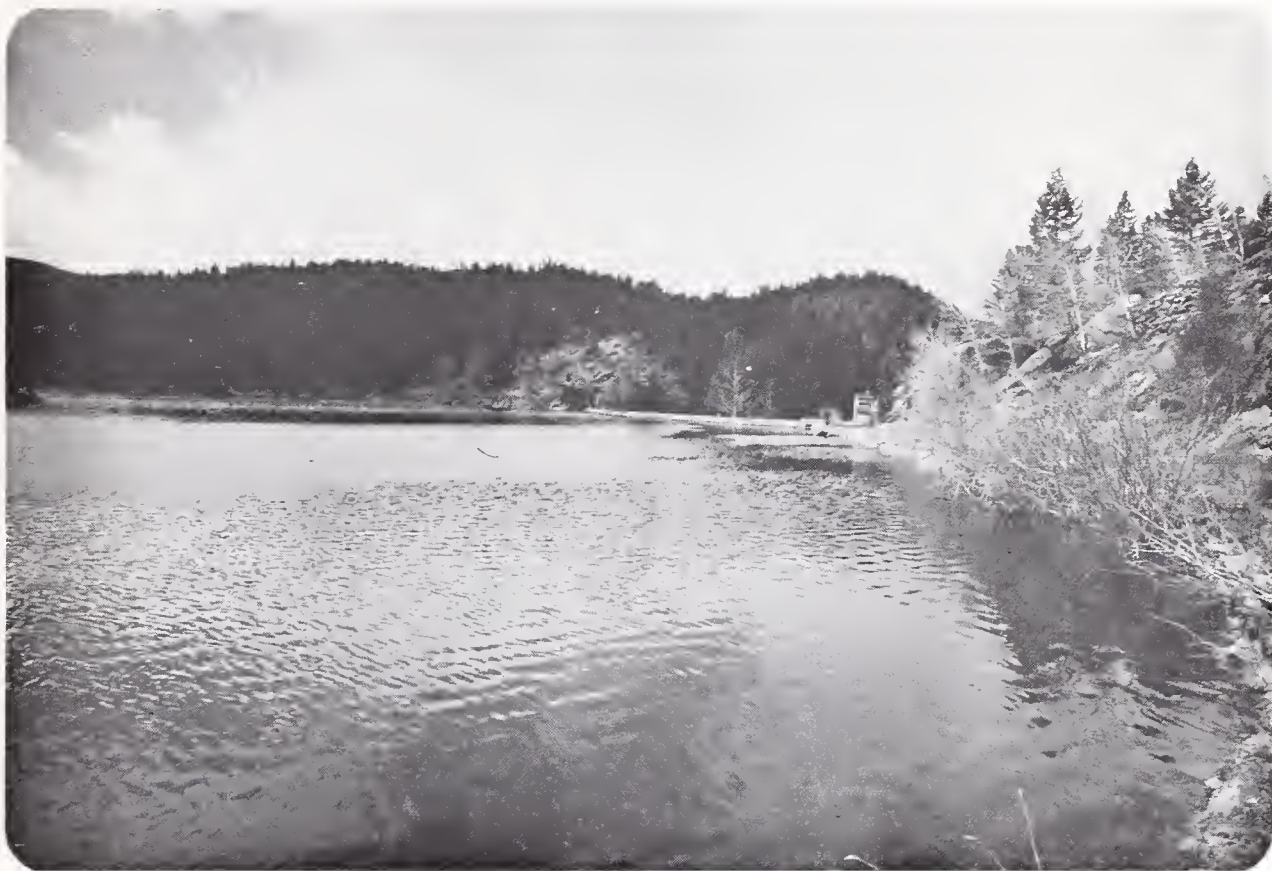
Photo 4. Looking downstream at dam

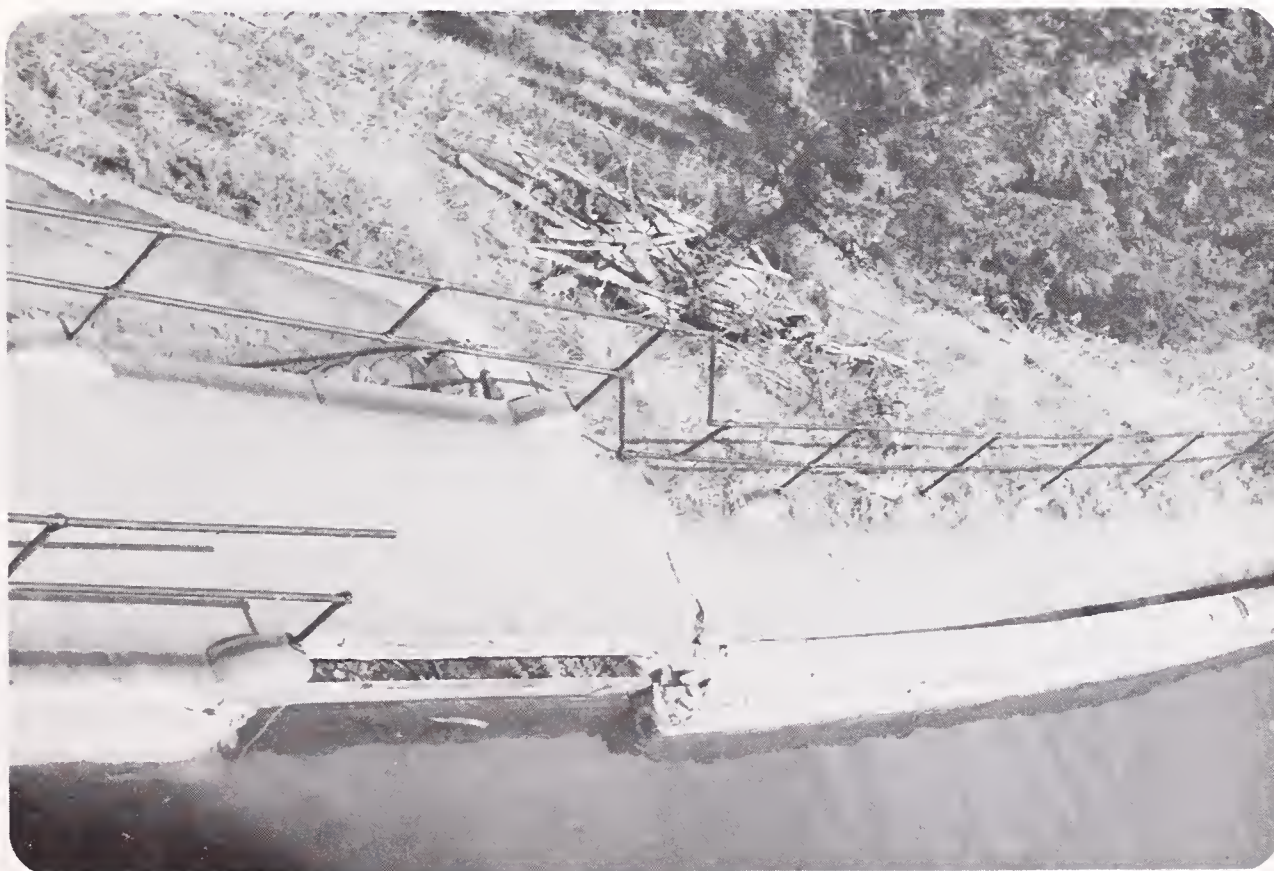
Photo 5. Plan view showing spillway intake and chute

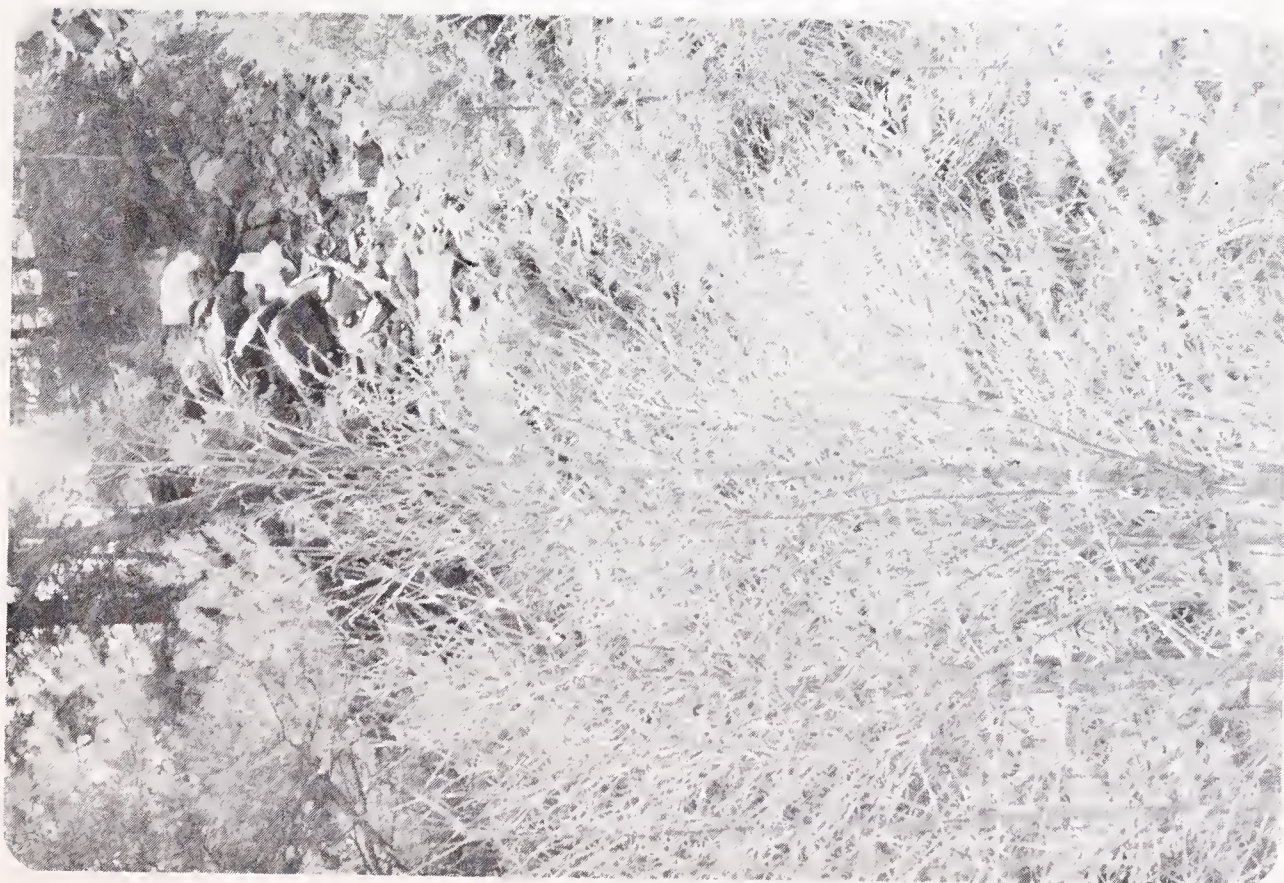
Spillway flows are conveyed over a series of steps to a chute having an invert elevation of 5,865 feet. The chute terminates in a free outfall to the canyon downstream of the dam (photos 5 and 6). The concrete surfaces of the chute and steps are badly deteriorated from weathering and are susceptible to damage from rocks falling into the structure from the rock slope into which the chute is cut. Overtopping of the 2.5-foot high chute sidewalls is possible; however, such overtopping is not expected to jeopardize the chute structure or the dam.

Photo 6. Spillway chute and downstream channel looking upstream

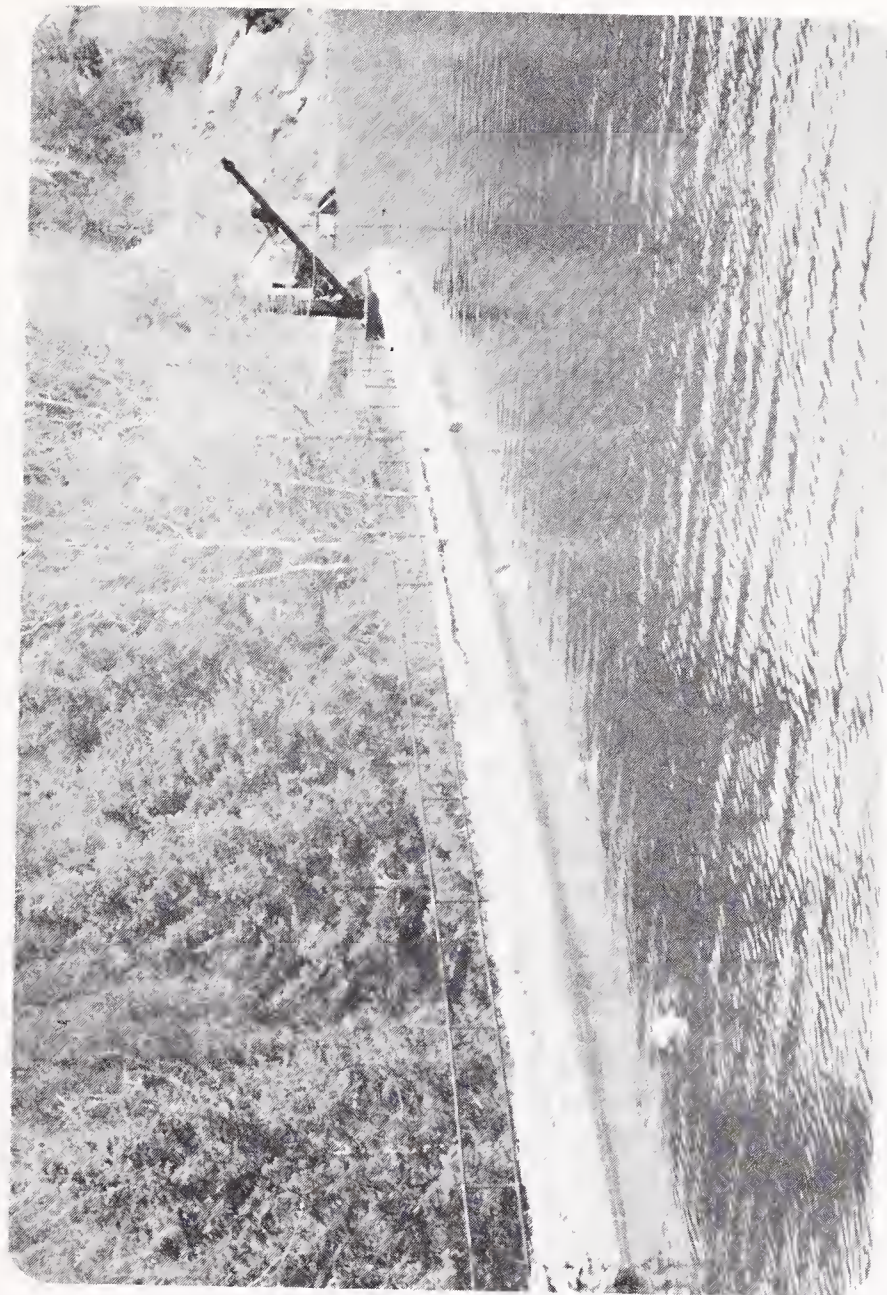
Photo 7. Upstream elevation from left bank

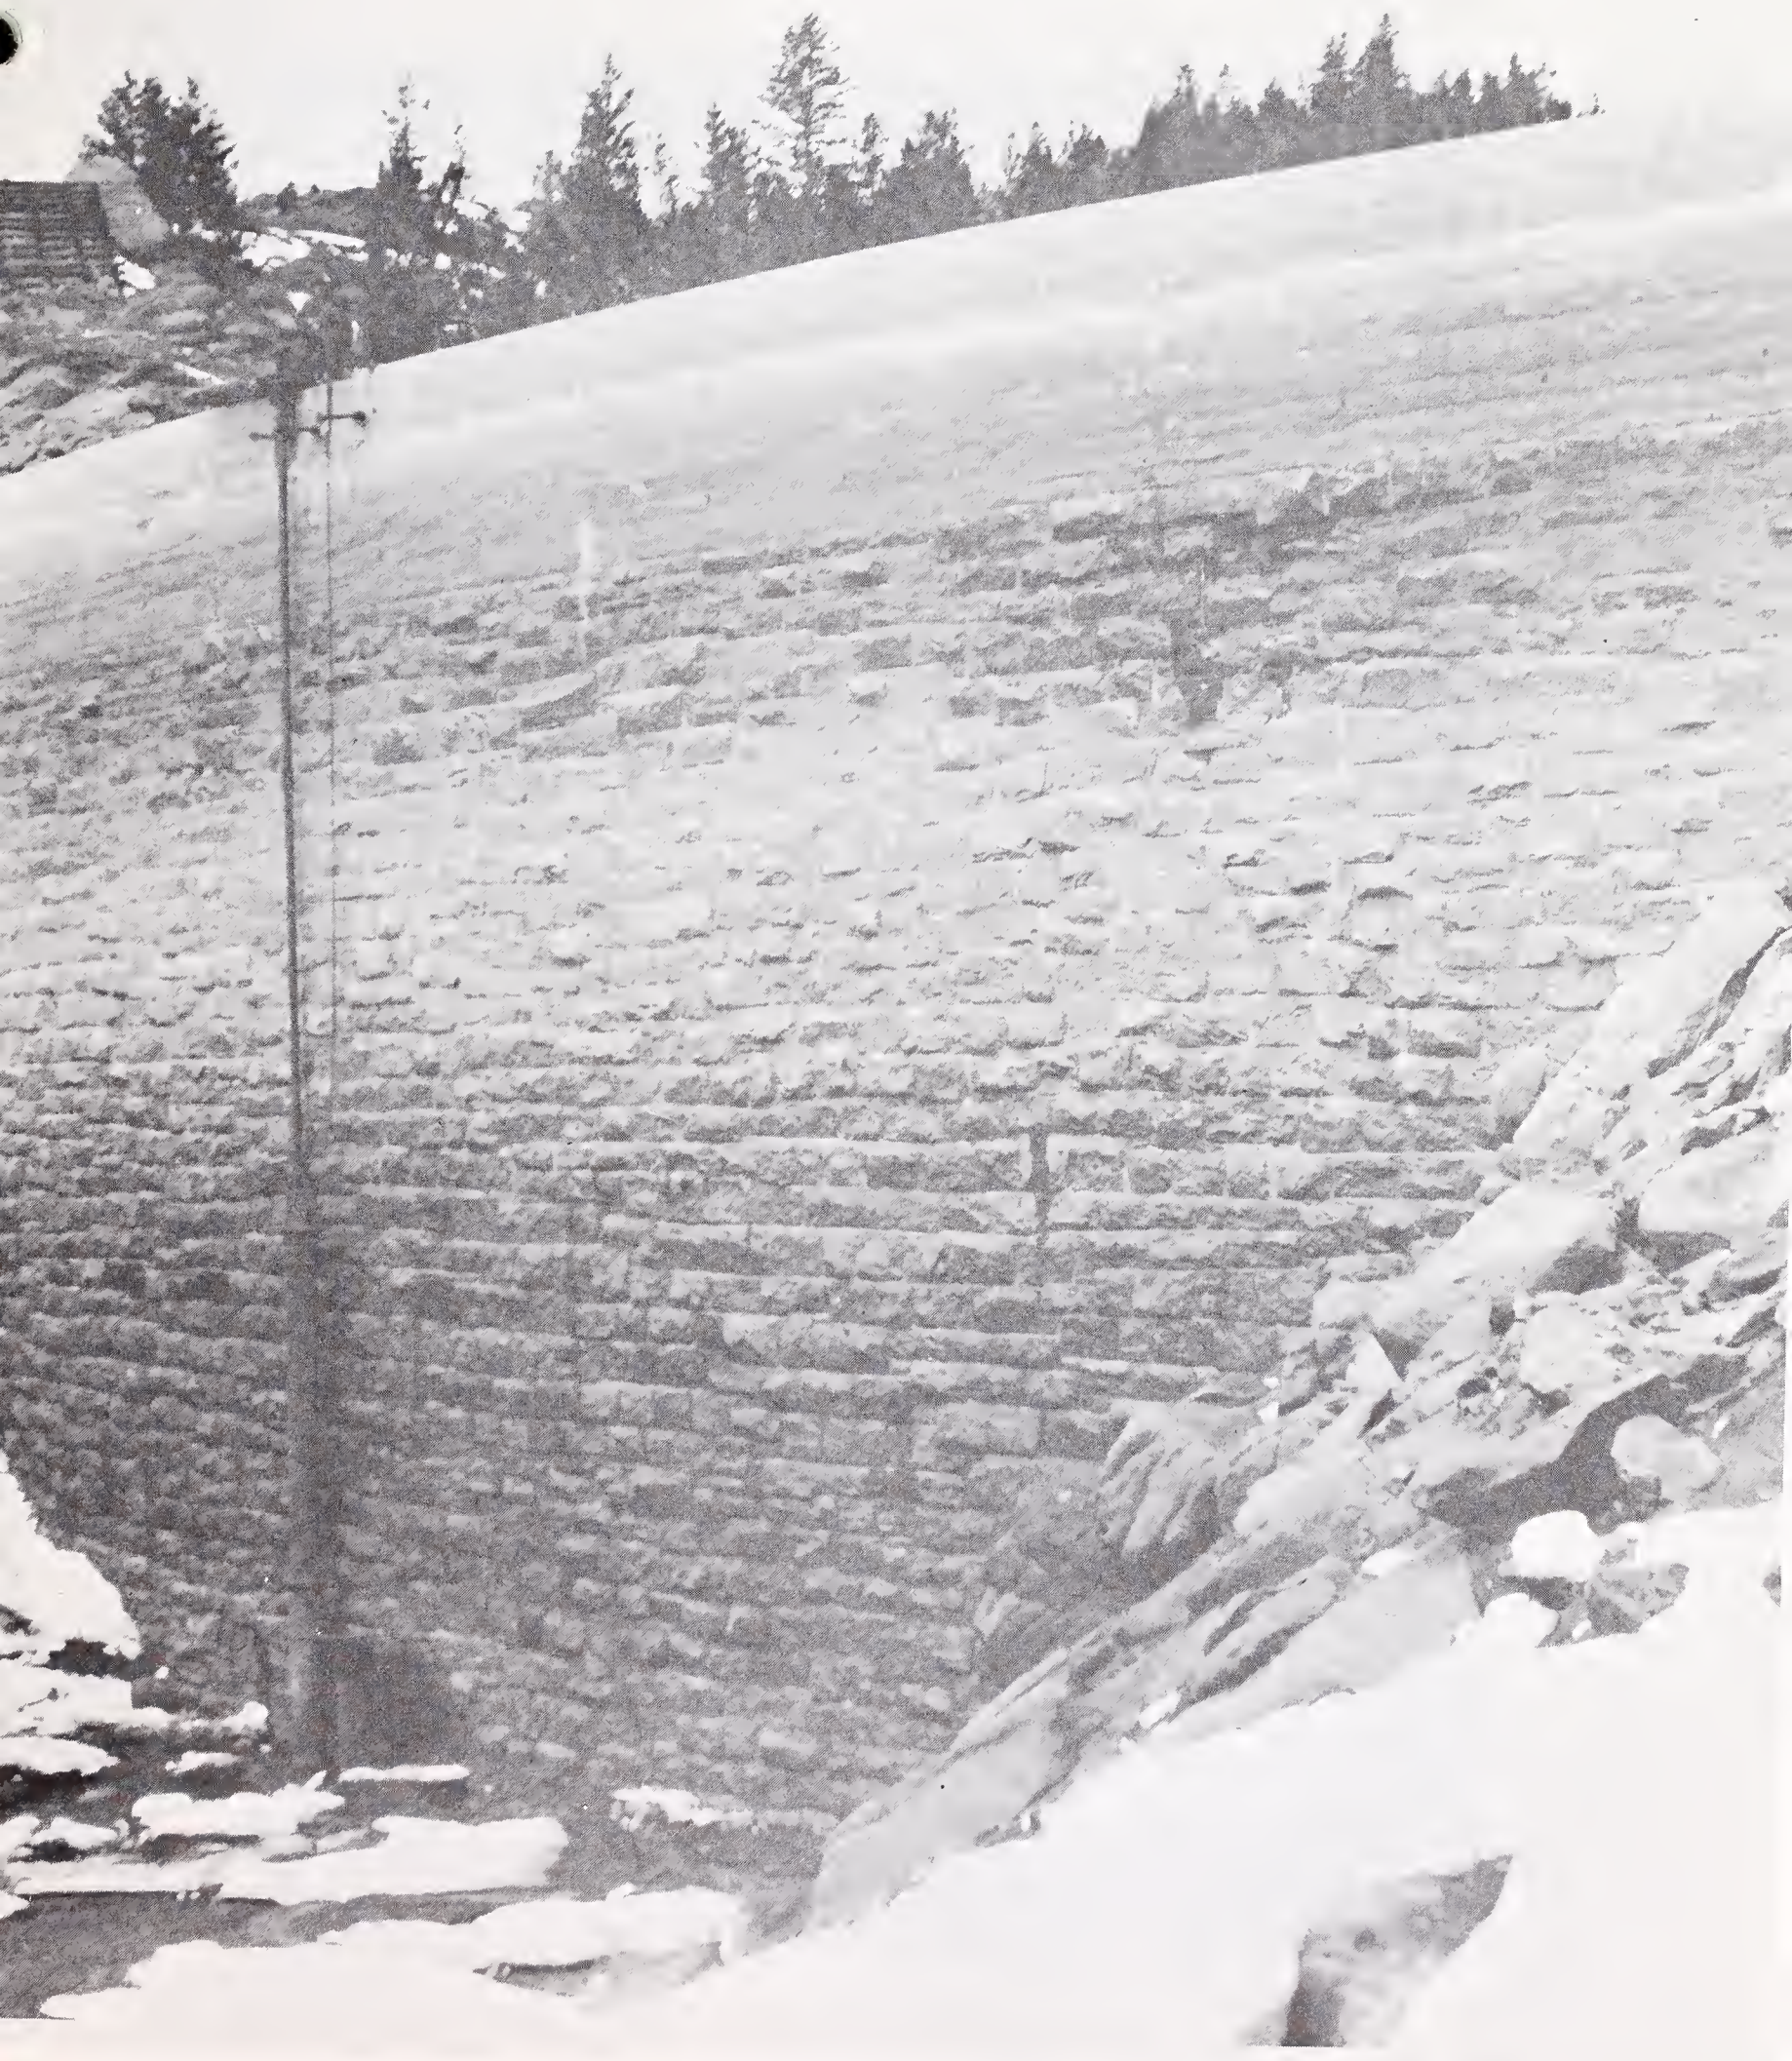
Photo 8. Upstream face of dam showing water face of finished granite blocks and the concrete overlay.

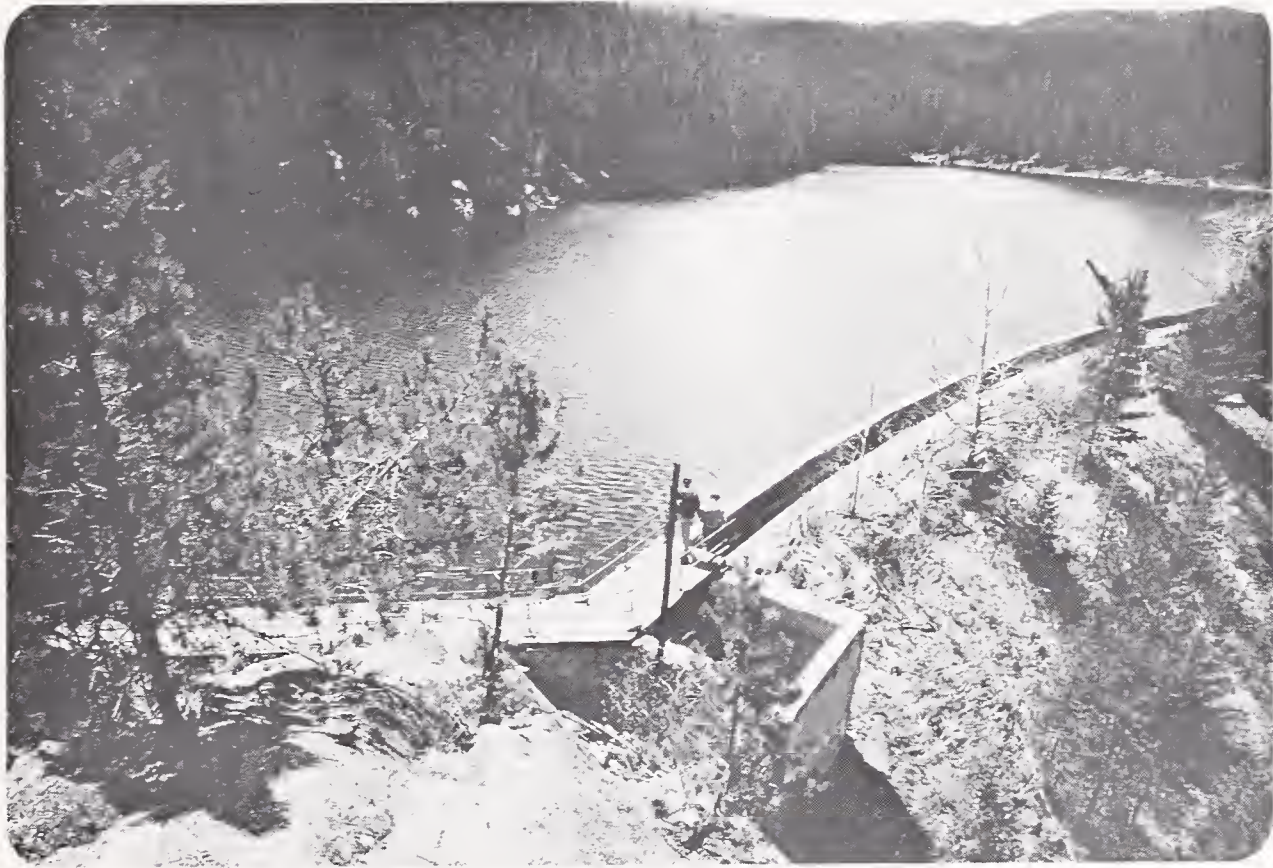
2.3.1.1 Embankment Cover. Near-surface material of the downstream earthfill cover is mostly sand (photos 9 and 10). The slope is well sodded, with a large number of old trees growing on the slope. A bulge was noted along the embankment toe near the right abutment.

Mr. Morrison, dam operator, reported that the bulge was material left by a slide that occurred about 30 years ago. The slide was caused by rupture of the bypass water pipeline from Basin Creek Dam No. 2 which passes over the crest and right abutment of Basin Creek Dam No. 1. The slide area has been repaired. In general, the earthfill cover appeared to be stable and in good condition.

Photo 9. View of dam from right abutment

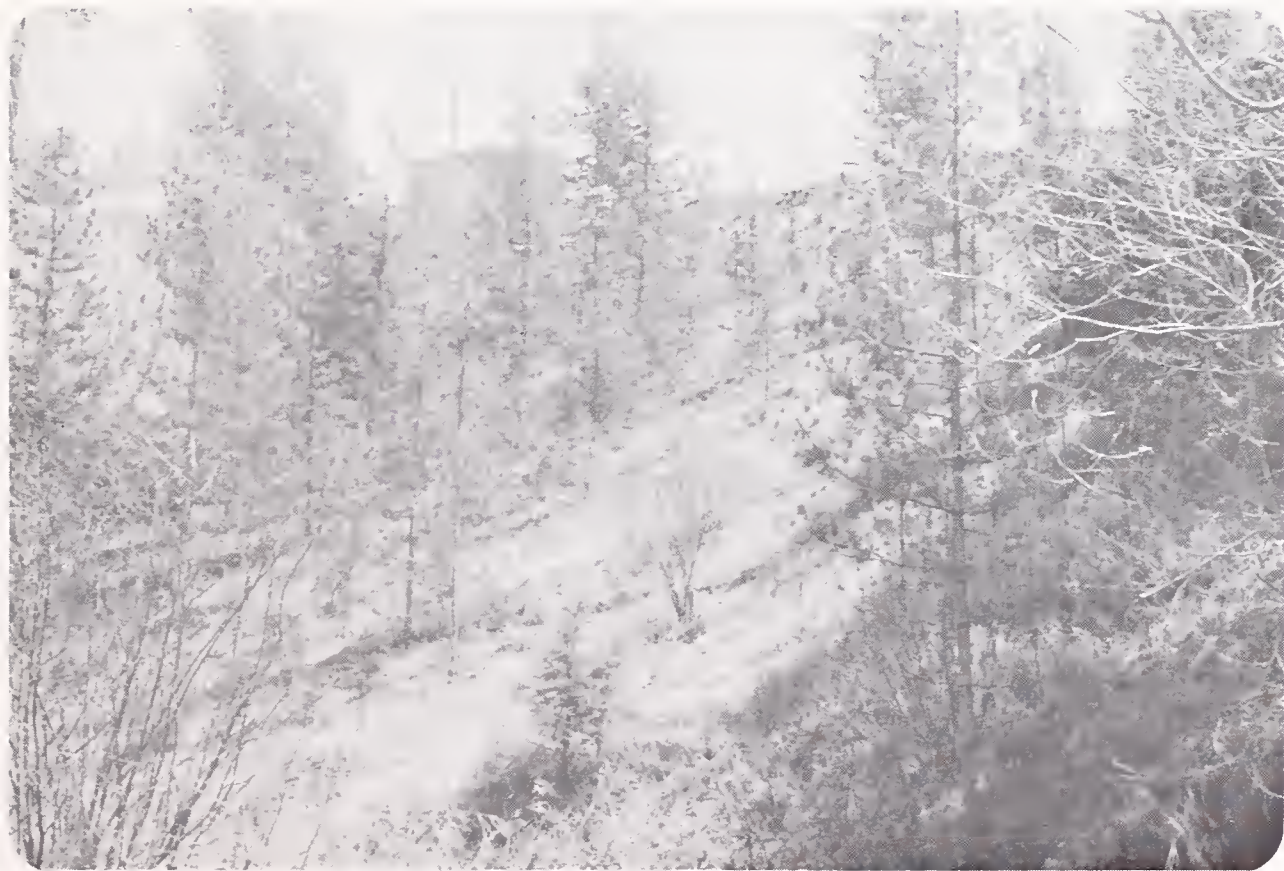
Photo 10. Downstream embankment cover

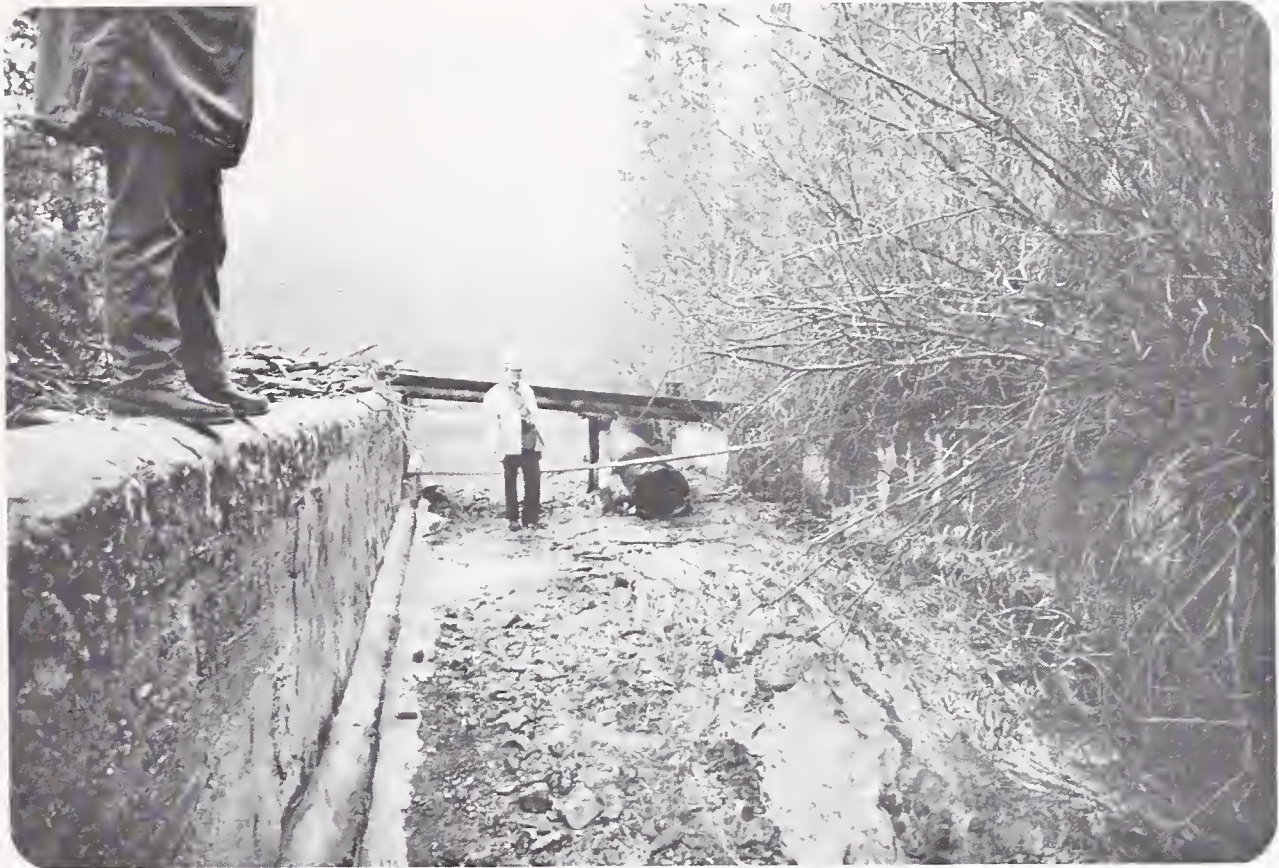
At the control section, the height of chute walls are 2.2 feet and the chute transitions through an abrupt contraction; therefore, the chute walls are subject to overtopping with spillway discharges of about 70 percent of maximum capacity. Downstream from the control section, the chute becomes steep, maintaining supercritical flow. About midway down the chute, the right wall abruptly changes alignment. This geometric configuration will result in formation of a wave which will undoubtedly overtop the chute walls at discharges less than maximum spillway capacity. Brush is overhanging the left wall of the chute essentially along its entire length and will impede flow down the chute, contributing to overtopping of chute walls. Considerable erosion has occurred at the terminus of the chute because adequate means of energy dissipation does not exist. Although the above conditions will result in unacceptable flow conditions in the spillway and chute, the structure appears to be located on rock, and overtopping of the spillway chute is not expected to result in failure of the dam.

Photo 11. Spillway chute (looking upstream), wooden bridge and steel pipe

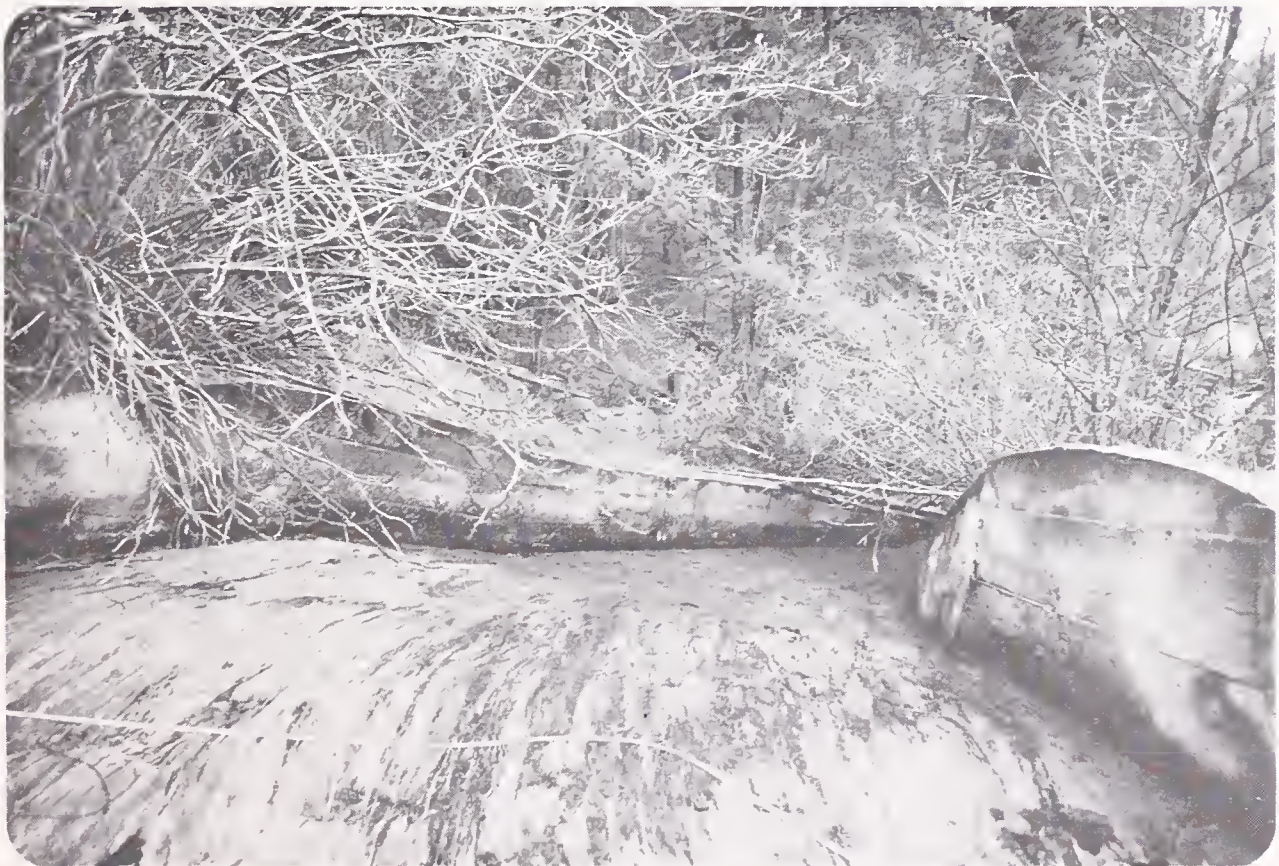
Photo 12. Spillway chute (looking downstream)

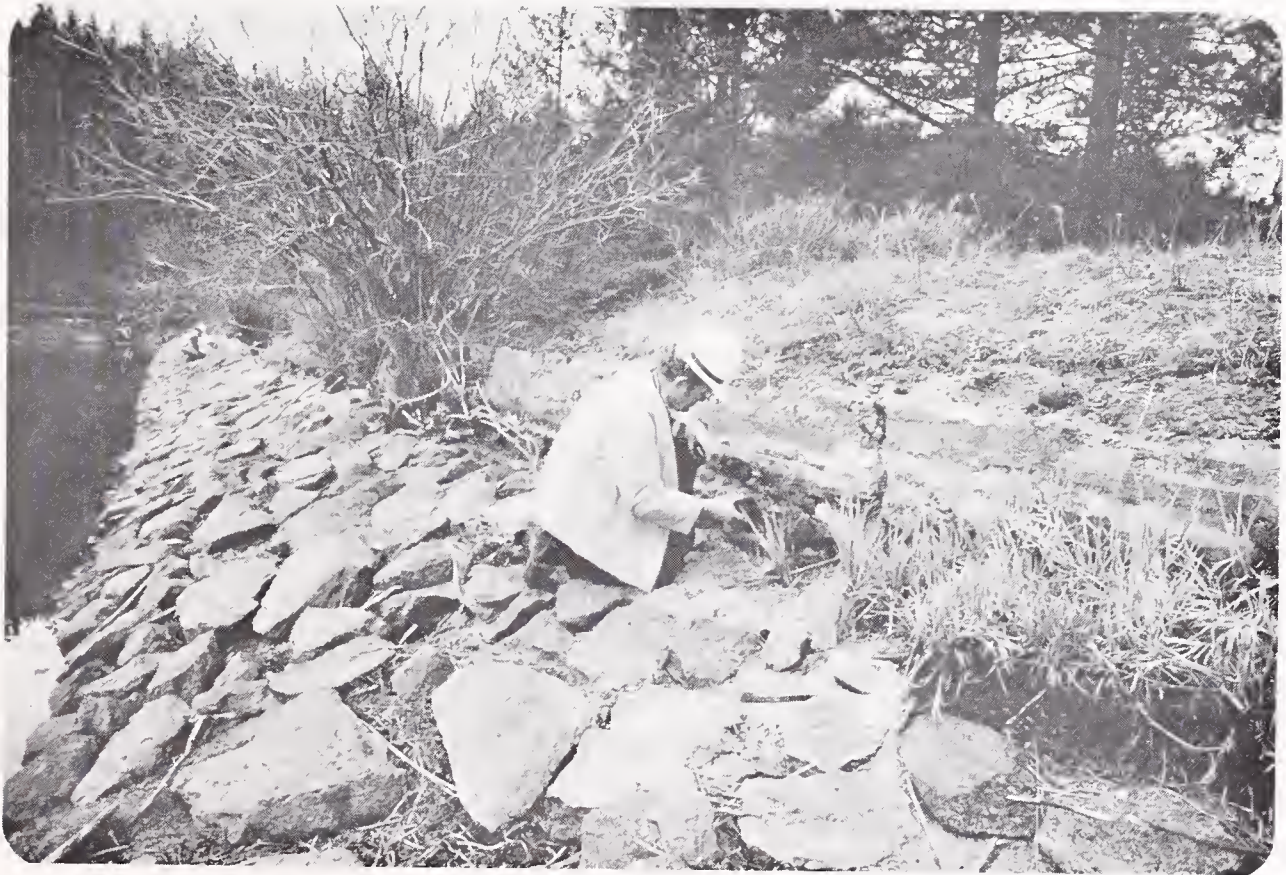
2.3.1 Embankment. The design drawings show top width of the dam as 22 feet; however, actual width is about 17 feet. Design drawings show upstream slope as 1 vertical on 1 horizontal, with riprap protection extending 3 feet above the concrete core wall. Actual upstream slope varies from 1 vertical on 1 horizontal near and at the embankment ends to about 1 vertical on 2 horizontal along the central portion of the dam embankment. At both embankment ends, riprap protection appeared to extend to the top of dam as shown on the original drawing (photo 13); however, along the central portion of the embankment, the top of riprap appeared to have settled to about 2 feet below the top of the exposed concrete core wall which is about 5 feet below the top of dam (see plate 10). Along the central portion of the upstream slope, the embankment material above the concrete core wall was slumping. Riprap appeared to be tightly interlocked and in good condition. Top of core wall is at elevation 6,201 feet, only 2 feet above normal full pool elevation of 6,199 feet. Severe storms could cause the reservoir level to rise above elevation 6,201 feet and water may pass over the core and cause instability to the downstream slope. Trees and brush were growing along the upstream edge of the embankment.

Photo 13. Upstream slope (note rock protection, slump, brush and exposed concrete cut-off wall)
